Roof Condition Report

9BSE-G - General Services

Intermountain Power Service Corporation
850 West Brush Wellman Road
Delta, Utah

June 2001

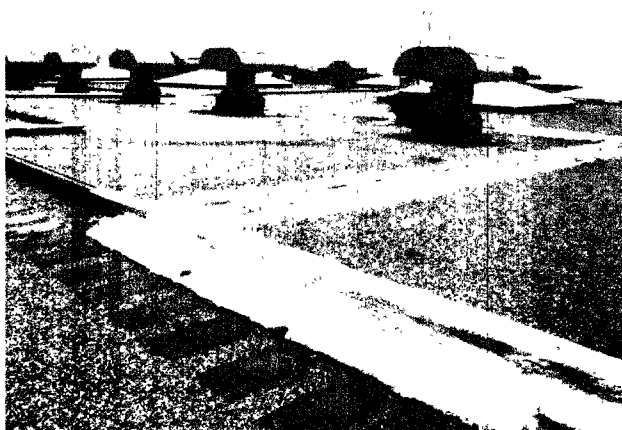
Photo No. 20

North area of the roof, looking east. North wall of building is to the left of photo.

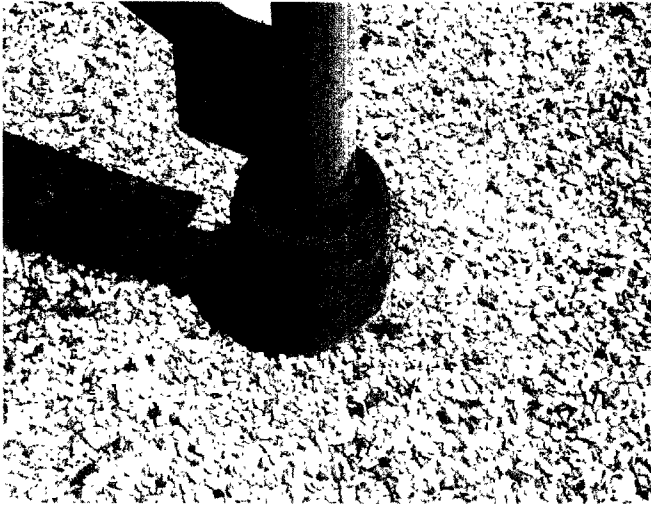
Photo No. 22
Pitch pans are almost empty.

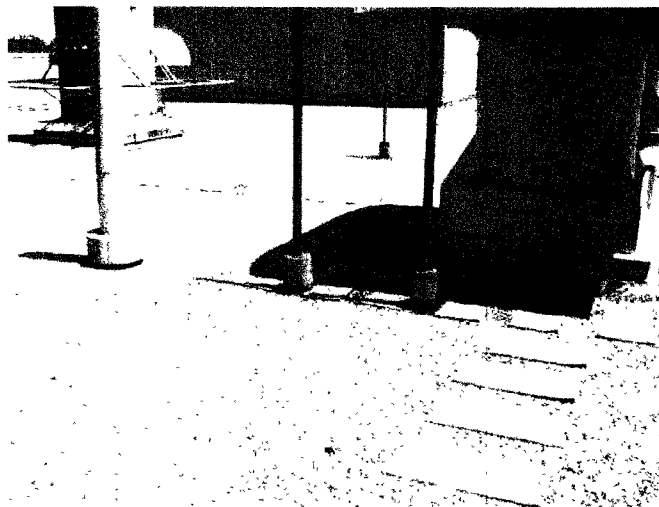
Photo No. 24
Roof equipment near the north wall of
the building - see left of photo for
parapet wall. Looking east.
